DOCUMENTATION IN
RESTORATION:
POSSIBILITIES AND
LIMITS OF
VISUAL
DOCUMENTATION FOR
MURAL PAINTINGS

JÜRGEN PURSCHE

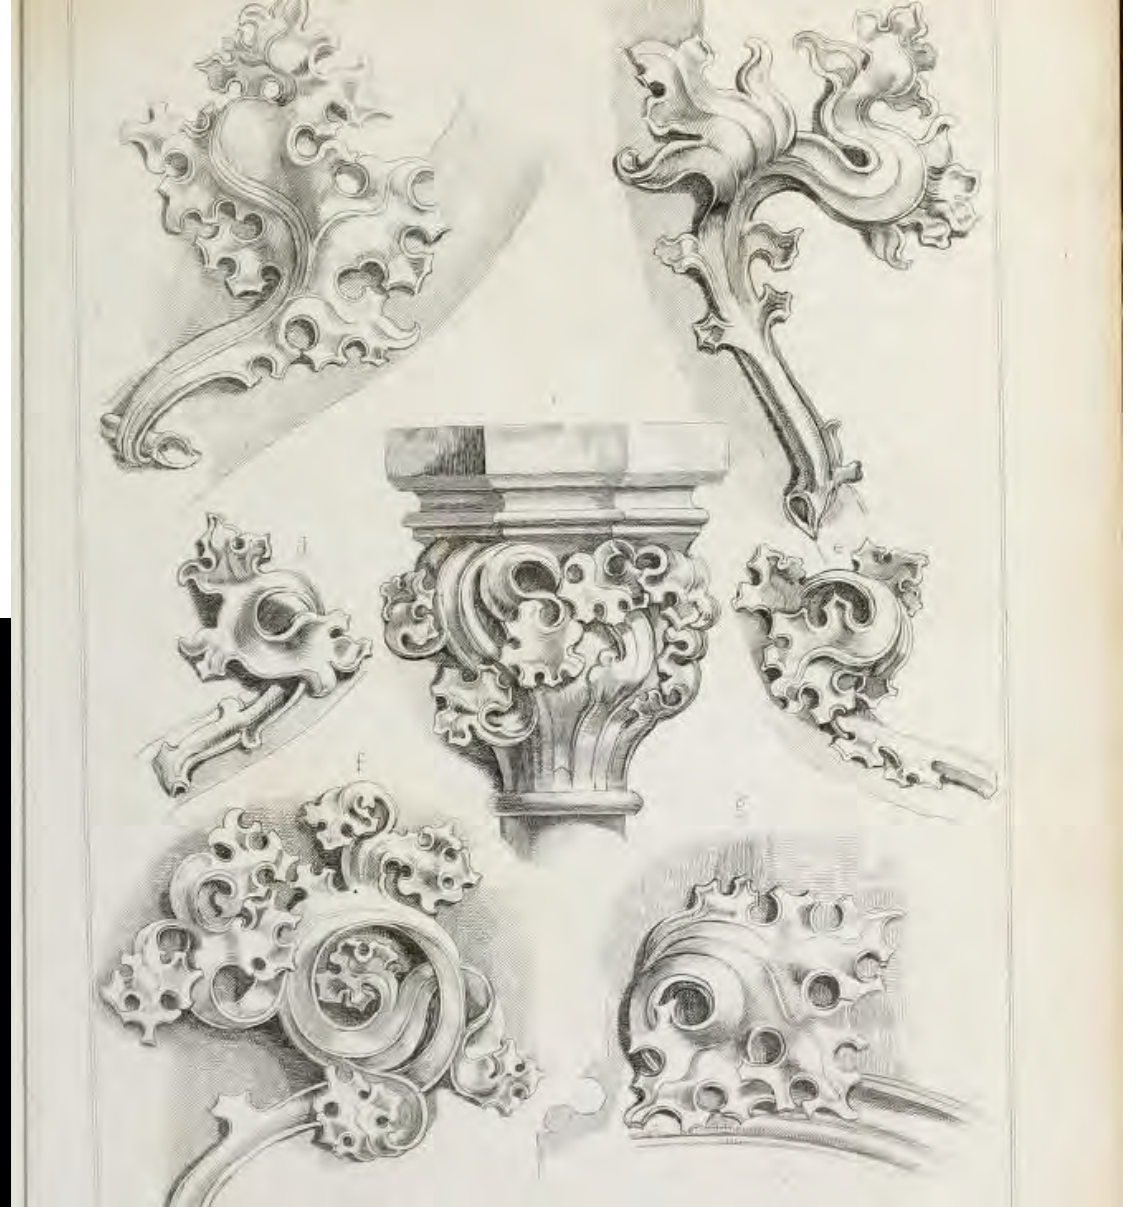
Figure 1. From Carl Heideloff, *Ornamentik des Mittelalters*, 200 copper plate illustrations with explanatory texts; new edition, Nuremberg, undated (ca. 1850), Vol. IV, Pl. 6.

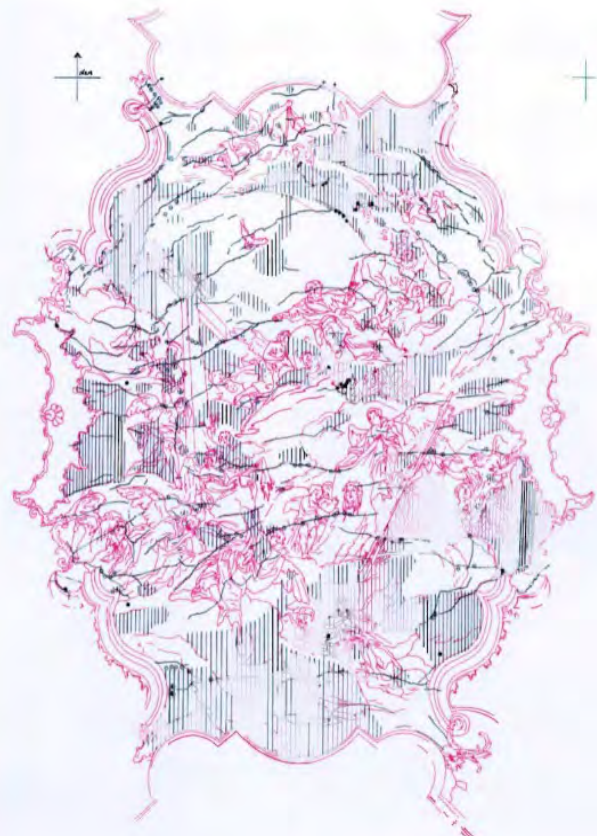
FIGURE 4. WIESKIRCHE, DISTRICT OF STEINGADEN (BAVARIA), FRESCO IN THE CHOIR (J. B. ZIMERMANN, 1749), DRAWING BASED ON A PHOTOGRAPH WITH GRAPHICAL DAMAGE ASSESSMENT AND MAPPING OF RESTORATION INTERVENTIONS, FROM: DIE INES. GESCHICHTE UND RESTAURIERUNG HISTORY AND RESTORATION, ARBEITSHEFTE DES BAYERISCHEN LANDESAMTES FÜR DENKMALPFLEGE, BD. 55, MÜNCHEN 1992.

Line drawings play a pivotal role as information carriers, offering a schematic representation and simplifying reproduction of a painting's composition. In conservation practice, these drawings typically replicate the painting's disposition from a photograph, akin to an under-drawing. Drawings on paper serve as crucial communication tools in conservation investigations. Such line drawings can be based on photographs from pre-investigations, orthogonal measuring systems like photogrammetry, or digitized and corrected photographic material (orthorectified). When available, precise hand-drawn architectural surveys or photogrammetric plans enhance the accuracy of these drawings. Fig 4-5

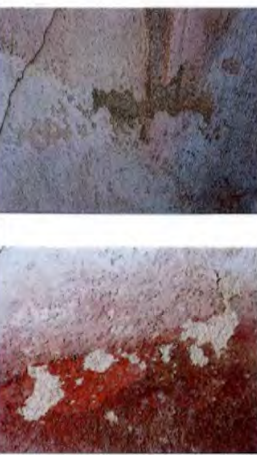
<p>Entlang den Haarrissen in den unteren Bereichen der Deckenmalerei sind einige Putzabplatzungen zu vermerken.</p>
P _H R _H

<p>Hohle Putzpartien sind in den Verästelungen der Haarrisse in den westlichen Zwickeln des Gewölbes zu finden.</p>
M _A

<p>Vereinzelte trennen sind in dem nach außen exponierten Teil des Gewölbes kleinere oder größere Malschichtschollen von der Putzoberfläche.</p>

Figure 6. Alteglofsheim, district of Regensburg, palace, oval room, ceiling fresco by C. D. Asam, 1730, damage glossary.

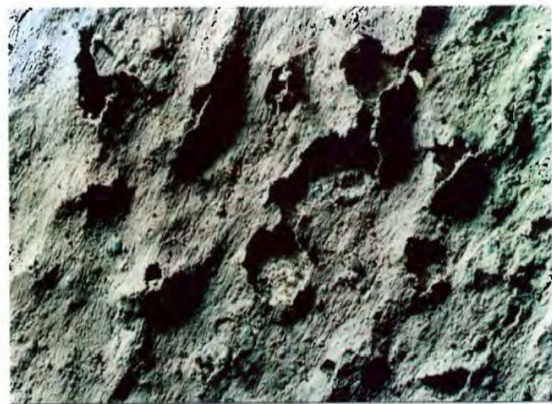
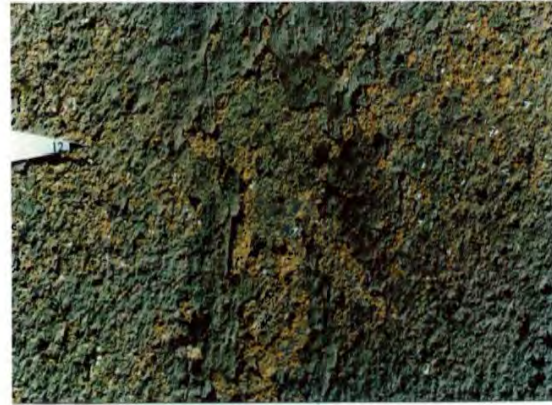
BEFUNDPROTOKOLL	FORTSETZUNG	Blatt
PLZ/Ort <input type="text"/>	Str./Platz/Nr. <input type="text"/>	Belund-Nr. <input type="text"/>
Garmisch - Partenkirchen, St. Anton Deckenfresco von Joh. Ev. Holzner, 1736 Untersuchung: 1995, H. Zernickel		
Legende der graphischen Dokumentation, Beschreibung der vorgefundenen Phänomene, Zustände / Schäden		
04 Abplatzende Malschicht, Malschichtfehlstellen.

Figure 7. Damage glossary, visual definition of damage phenomena: bursting or detached paint layer losses.

A damage glossary serves as a systematic compilation and visual representation of representative damage phenomena in art or buildings, serving as an initial step in problem-solving. It offers:

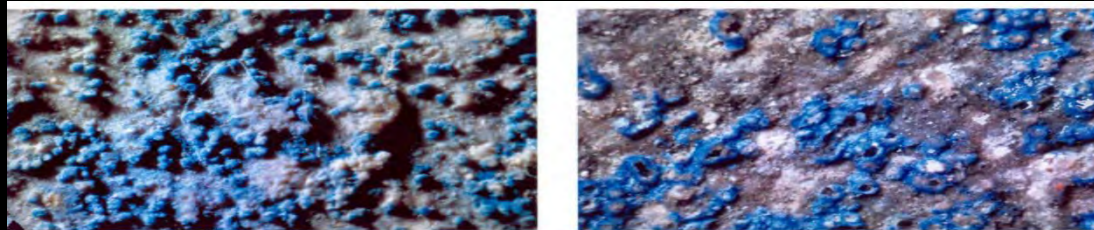
Figure 9 a/b. Blue colour layer (lapis lazuli) on grey veneda, dot-like and/or spherical changes in the paint layer (mostly through influence of humidity and the formation of gypsum).

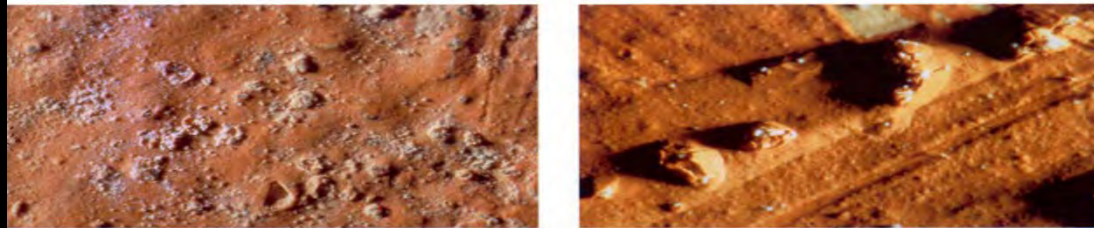
Figure 10 a/b. So-called pustules, dot-like crystallizations of salts (mostly through the formation of gypsum on the surface).

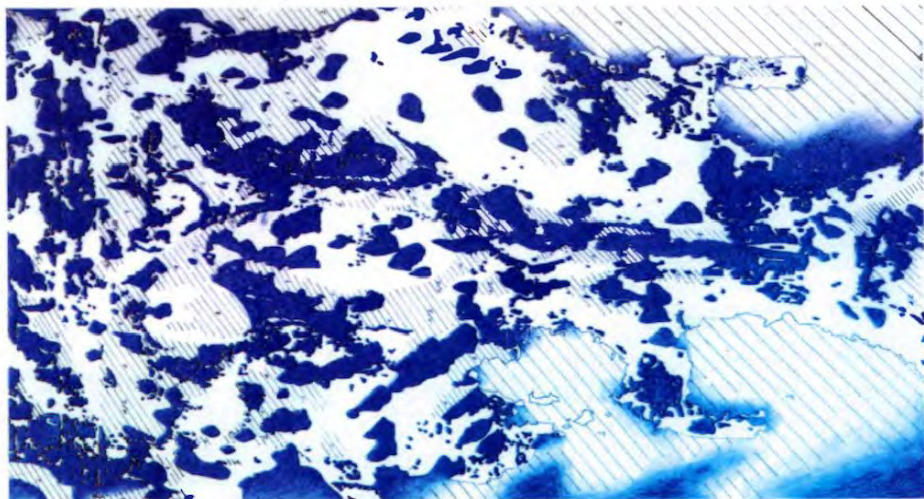
Figure 14. Augsburg, Fugger House, interior decoration of the so-called "hall of the muses" by F. Sustri/A. Ponzano 1570/71; detailed mapping of the heavily damaged original wall paintings on two plastic overlays over a detailed black-and-white photograph, coloured pencil and black ink (by C. Salzberger)

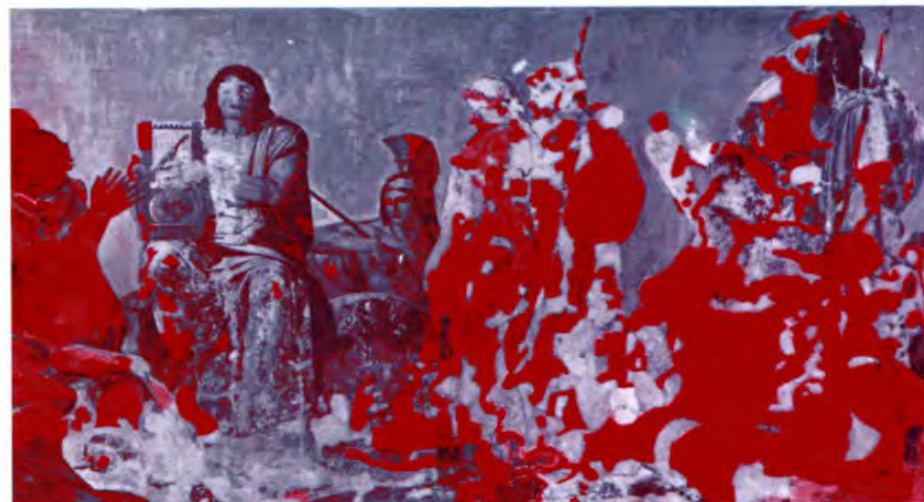
Figure 15. Munich, Ludwig-Maximilian University, lecture room no. 115, Ludwigstr. 28, R. V. Langer 1834, mapping of the salt efflorescence, foil on a black-and-white photograph, coloured pencil (detail).

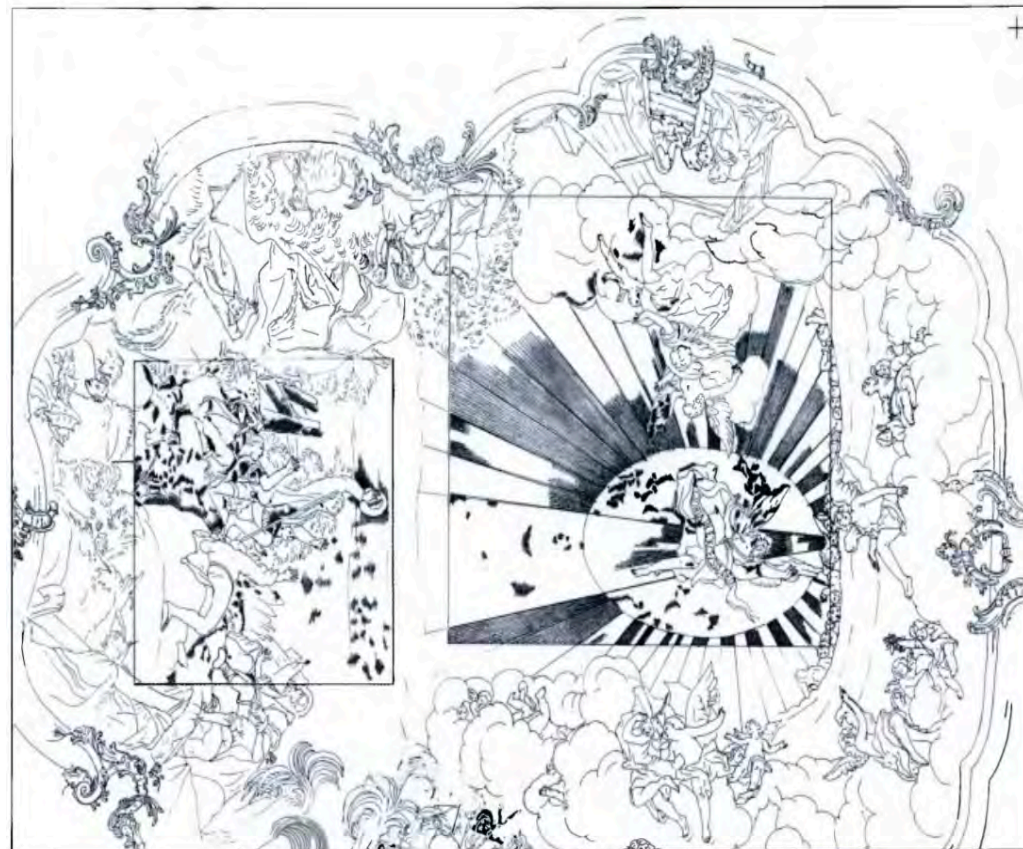
Figure 16. Pilgrimage church Vierzehnheiligen, district of Lichtenstein (Bavaria), J. I. Appiani 1764, choir fresco, graphic documentation drawing copied after a survey photograph (see Figure 4) with partial mapping with a lead pencil of repainting from the 'restoration' of 1959.

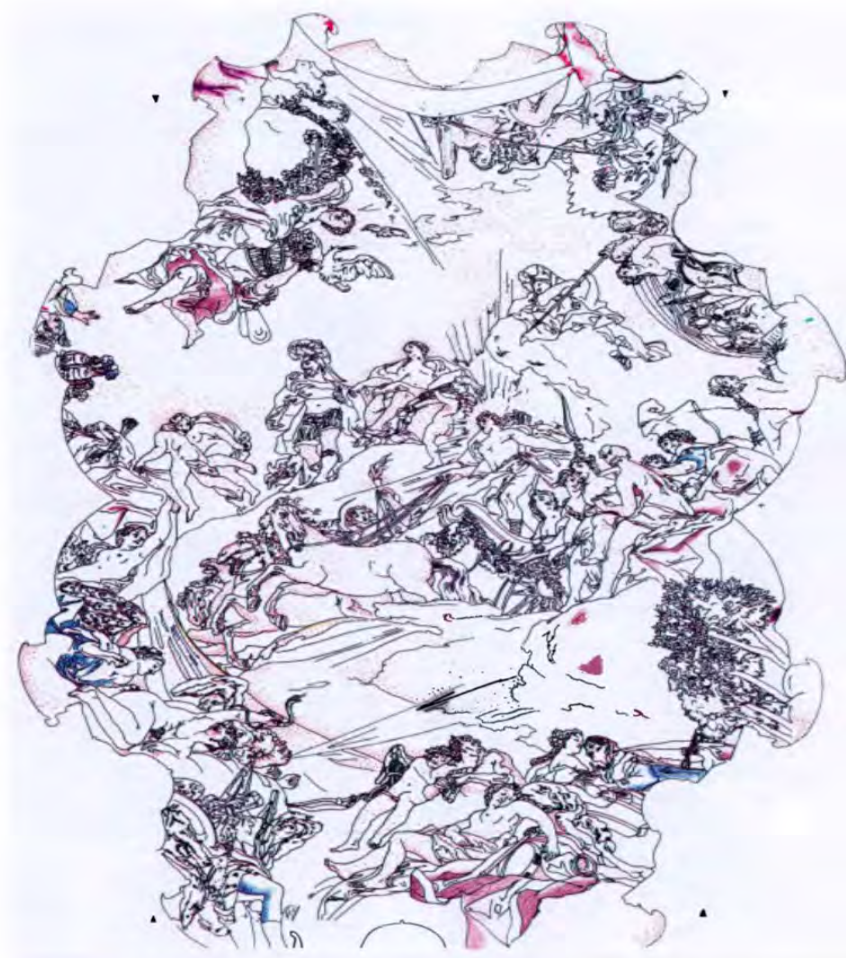
Figure 17b.
 See Figure 17a.

Figure 17a. Alteglöfshheim, palace, so-called "oval hall", C. D. Asam, 1730, graphic documentation drawn after a survey photograph (see Figures 1 and 16), mapping of paint-layer damage with a coloured pencil.
