Recording, Documentation, and Information Management for the Conservation of Heritage Places

ILLUSTRATED
EXAMPLES

CONDITION ASSESSMENT: WORKING WITH INFORMATION

Condition Survey

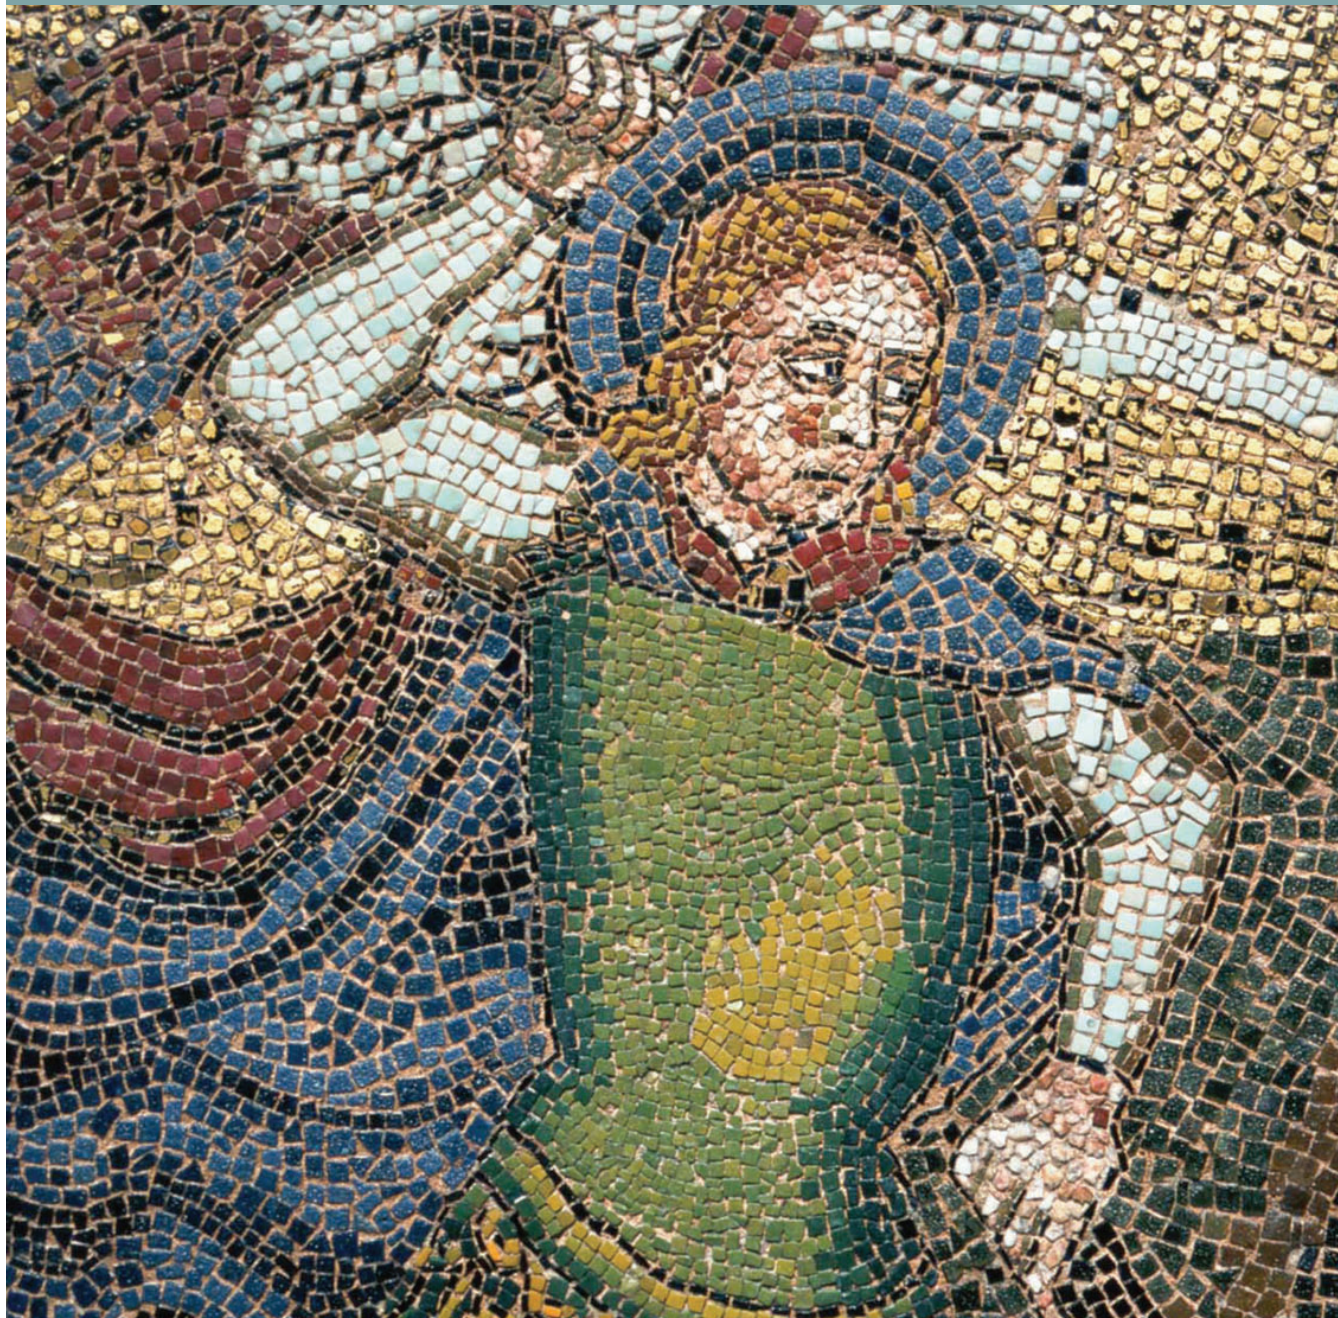
Detail of an angel, shown after cleaning, in the *Last Judgment* mosaic, above the entrance to St. Vitus Cathedral, Prague.
Photo: Dusan Stulik.

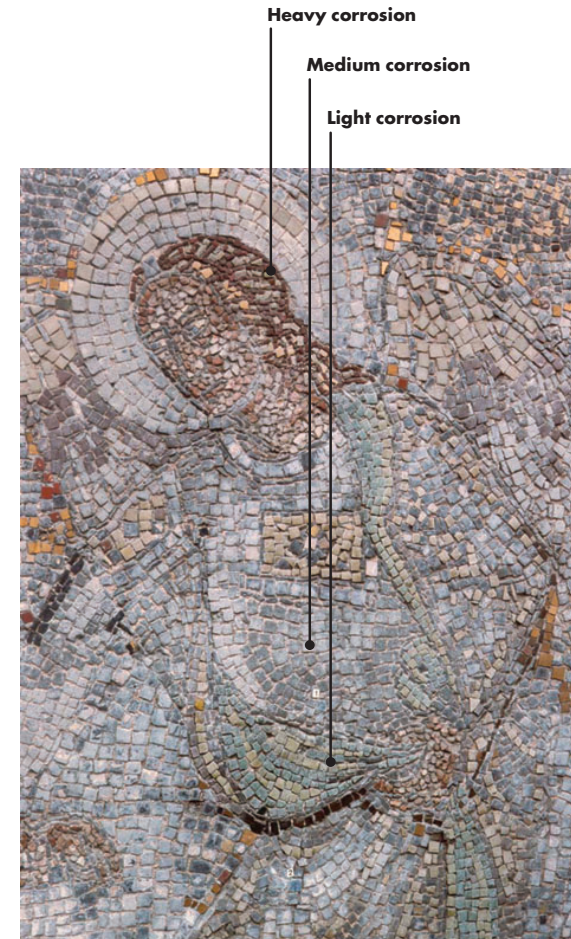
Detail of a figure in the mosaic prior to cleaning, showing levels of corrosion. Photo: Dusan Stulik.

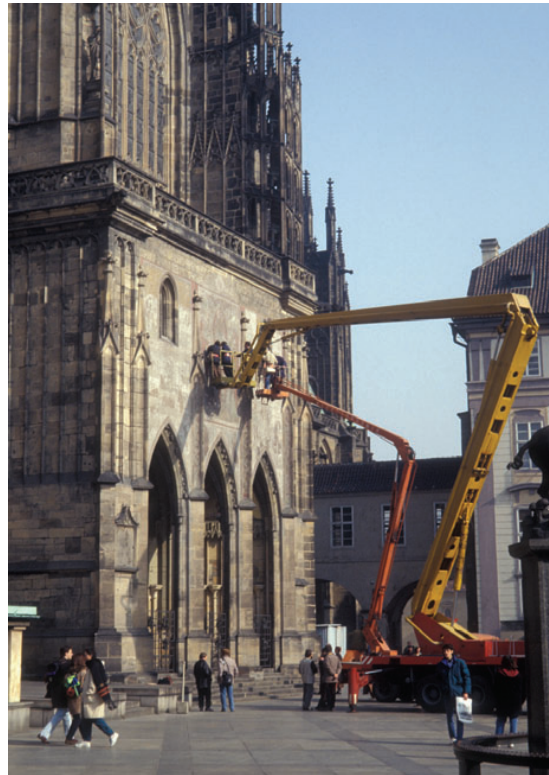
Conservators at St. Vitus Cathedral inspecting the mosaic, recording conditions on transparencies overlaid on rectified photographs of the facade. Photo: Dusan Stulik.

Information collected by conservators on the transparencies was scanned and imported back into the computer model. Prior to collecting information on the transparencies, it was found that certain colors—green, yellow, and other light colors—were not optimal for scanning. Therefore red, dark blue, black, brown, magenta, and orange were chosen for use. It was also important that only

new markers were used. A condition legend was created that corresponded to each color. Red referred to cracks, magenta to traces of original gold, and blue to missing tesserae. In addition, extra transparencies were made available if the conservator made a mistake; no corrections were possible given that the transparency was scanned. All of these issues were carefully explained to the conservators, who were required to change their usual methods.

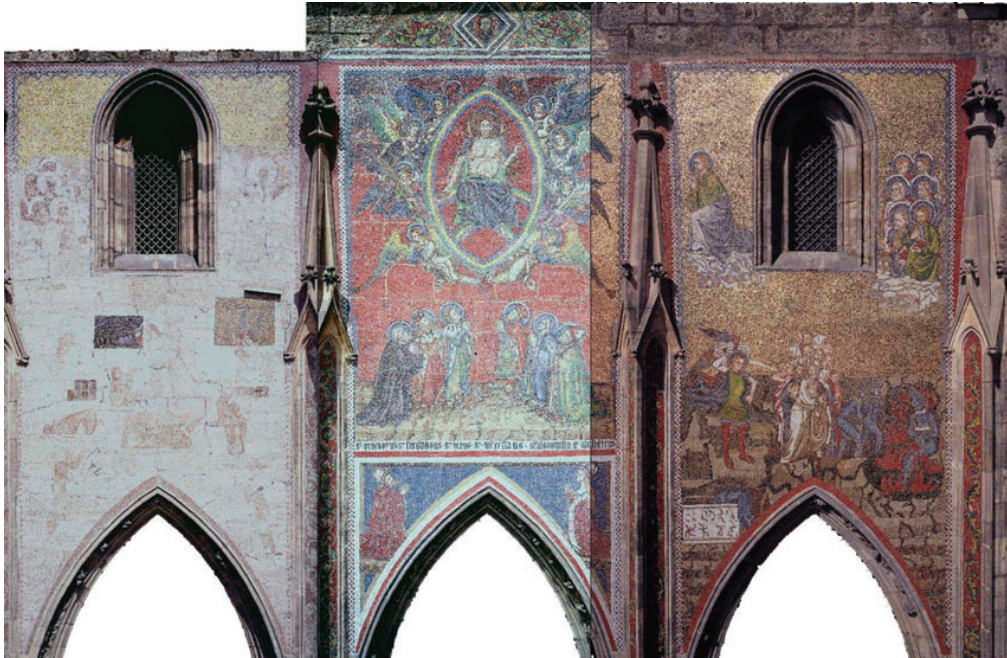
Rectified images of the facade, showing its state before conservation (*left*), after treatment (*center*), and after gilding (*right*). Images: Jaroslav Zastoupil.

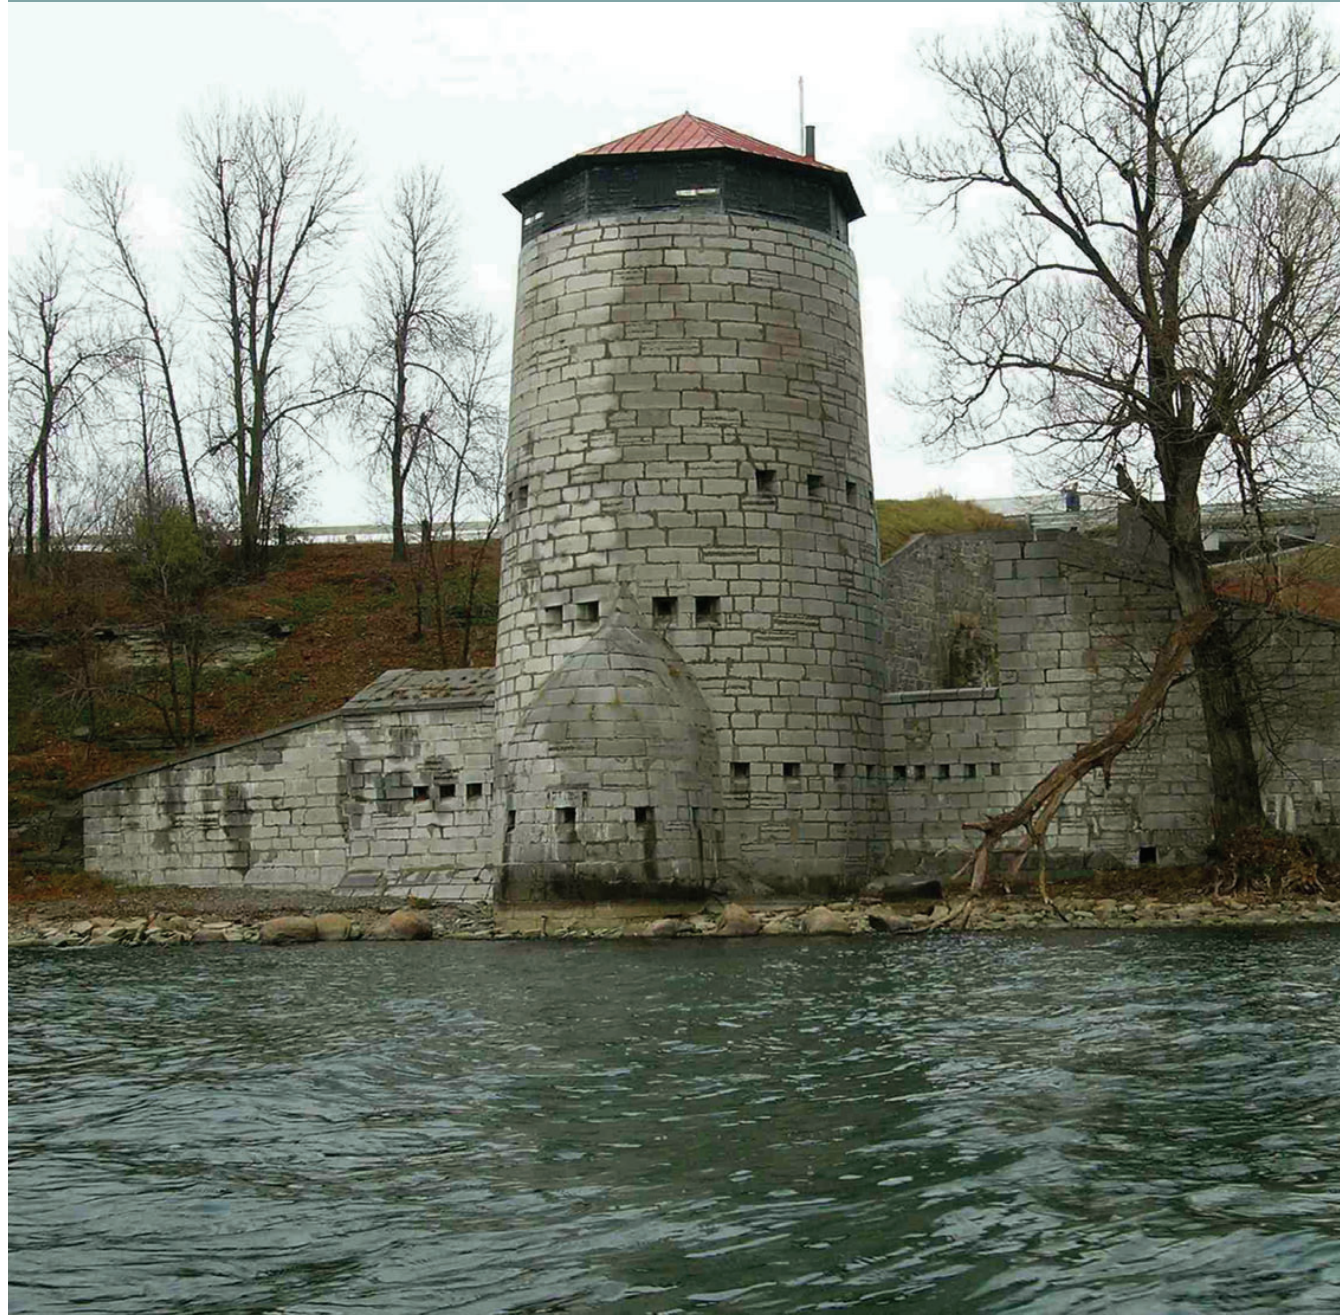
The East Branch ditch tower of Fort Henry, overlooking Lake Ontario and the mouth of the St. Lawrence River. Photo: Christian Ouimet © Heritage Conservation Directorate, Public Works and Government Services Canada.

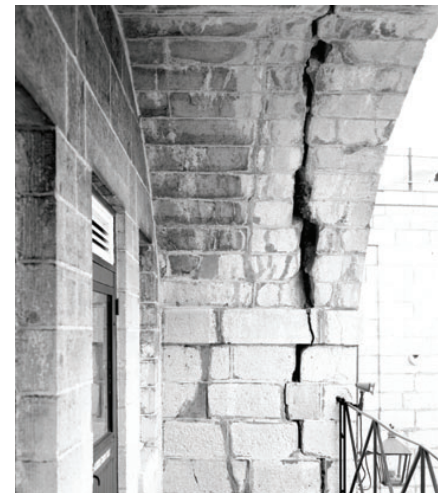
Fractures and spalling of the limestone blocks in an archway of the redoubt. The mortar joints had also deteriorated significantly. Photo: © Fort Henry National Historic Site of Canada–Archives.

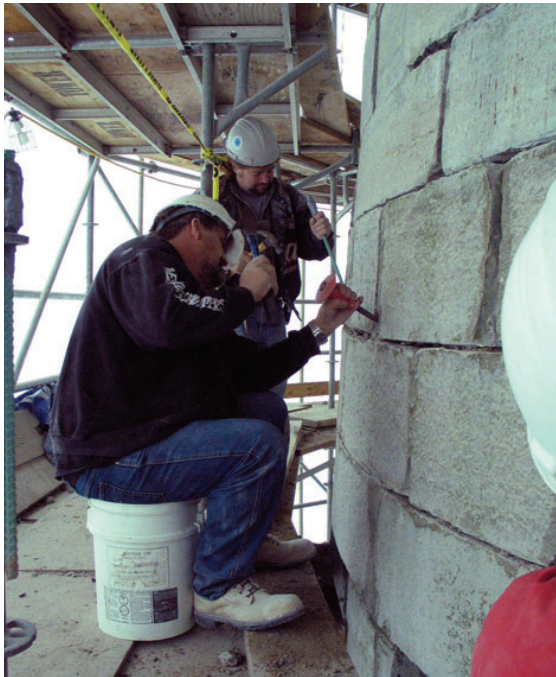
Workers removing deteriorated mortar from the East Branch ditch tower for repointing. Photo: © Fort Henry National Historic Site of Canada–Archives.

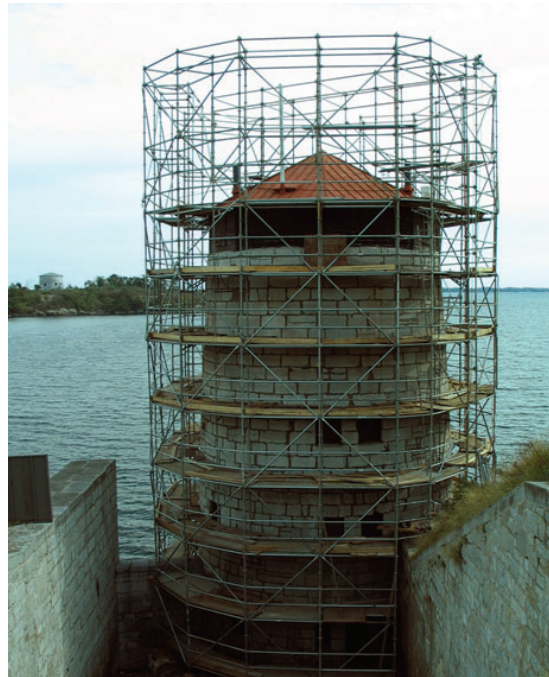
The scaffolded East Branch ditch tower during the restoration project. Photo: © Fort Henry National Historic Site of Canada–Archives.

project commenced in 2004 to waterproof, repair, and stabilize the redoubt, and in fall 2006, conservation work was begun on the East Branch ditch tower to restore the roof and repair the stone walls. This work continues in 2007 on the West Branch ditch tower. Other conservation projects currently in the planning and implementation stages include the repair and repointing of the advanced battery and the north wall of the redoubt. Each intervention reflects a commitment to respecting the established heritage character of the site.

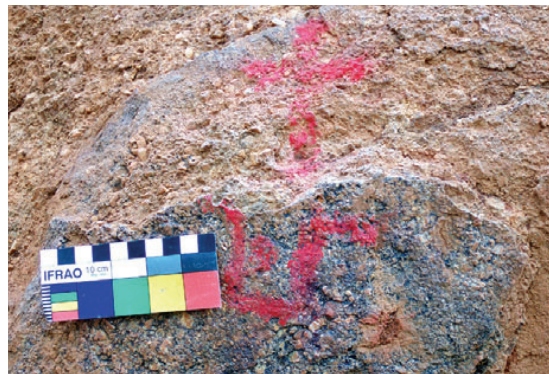
Red graffiti obscuring rock art at Uluru.
Photo: © Mick Starkey.

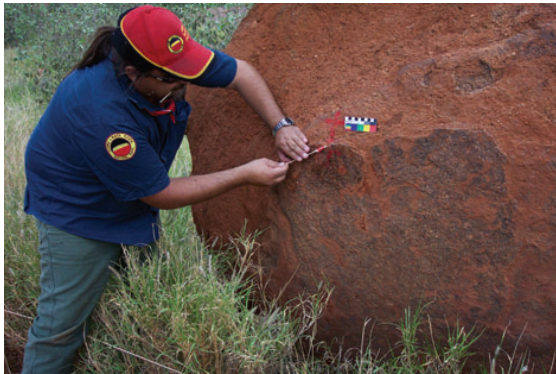
A conservation team member removing graffiti at Uluru. Photo: © Cliff Ogleby.

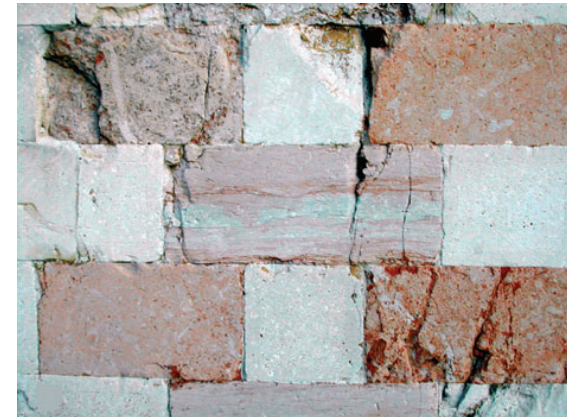
Detail showing the masonry deterioration of the facade caused by seismic stress. Photo: © Marco Tallini.

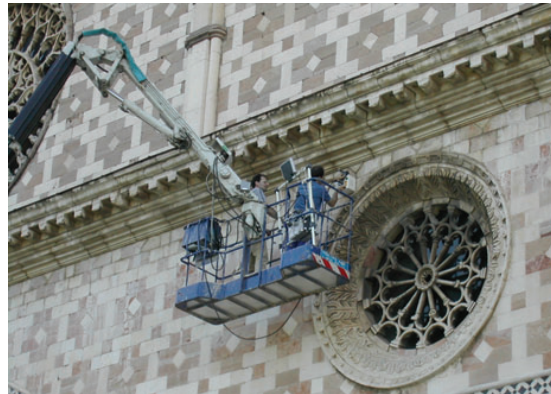
Technicians using GPR for data acquisition near the basilica's rose window. The GPR system was applied directly to the building's surface. Photo: © Marco Tallini.

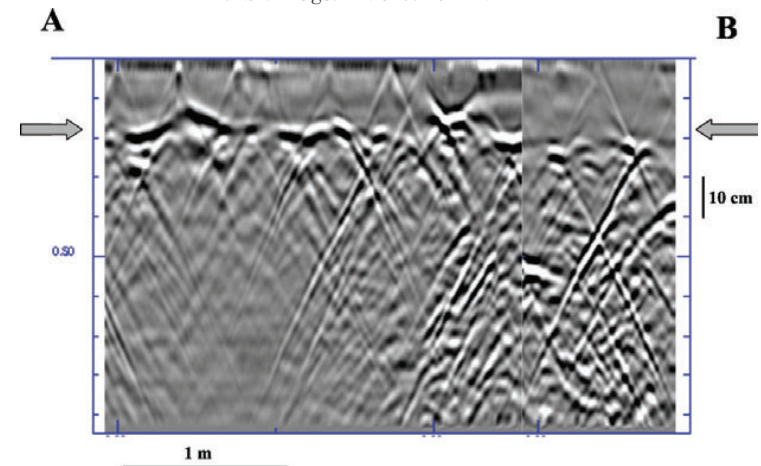
A 1600-MHz radar section. The arrows highlight strong anomalies probably related to the widespread detachment of the ashlar facing from the rubble core or to zones of degraded mortar. Image: © Marco Tallini.

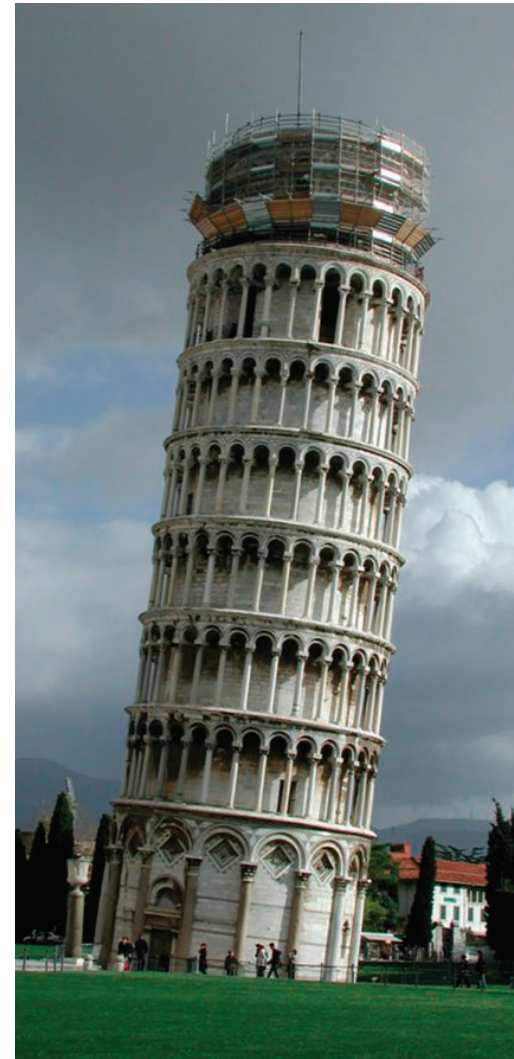
The Tower of Pisa in 1995, with its belfry under conservation during the preliminary stabilization phase. Photo: © Gary Feuerstein, 1995.

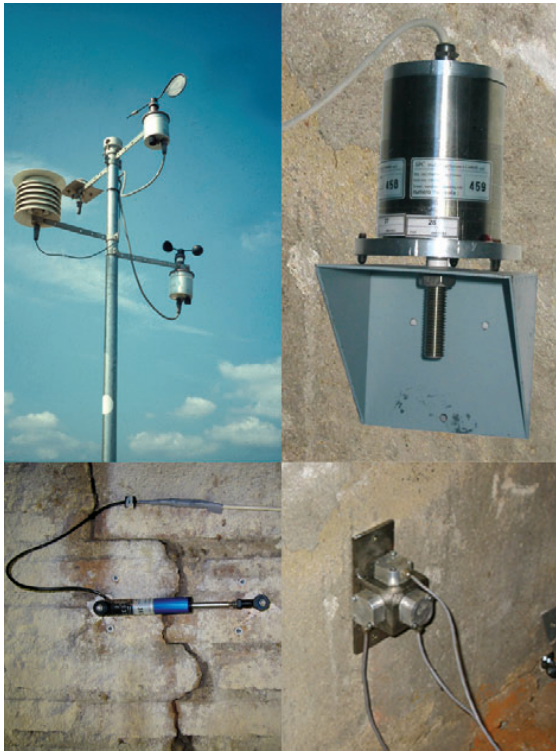
Clockwise from top left: weather station; biaxial inclinometer, which measures tilt in both north–south and east–west directions; accelerometers, which measure three-axis seismic acceleration; transducers, which measure strain on cracks. Photos: © Giorgio Croci.

movement is due to a strong wind, a sunny day, or, more important, their intervention or an impending failure. A weather station was positioned on top of the tower to record wind direction and speed, ambient temperature, and radiation from the sun. Thermometers were placed inside the masonry on different floors to correlate deformations of the structure with temperature. These measurements record how the structure reacts to environmental forces and were useful before and during work on the tower.

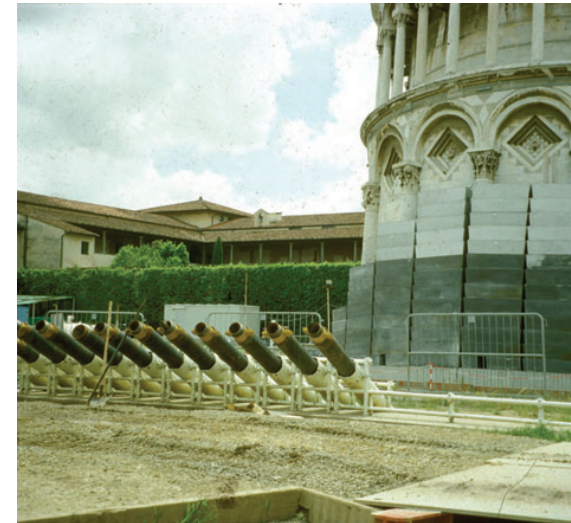
Lead weights were used to reduce the tower's lean. Photo: © Giorgio Croci.

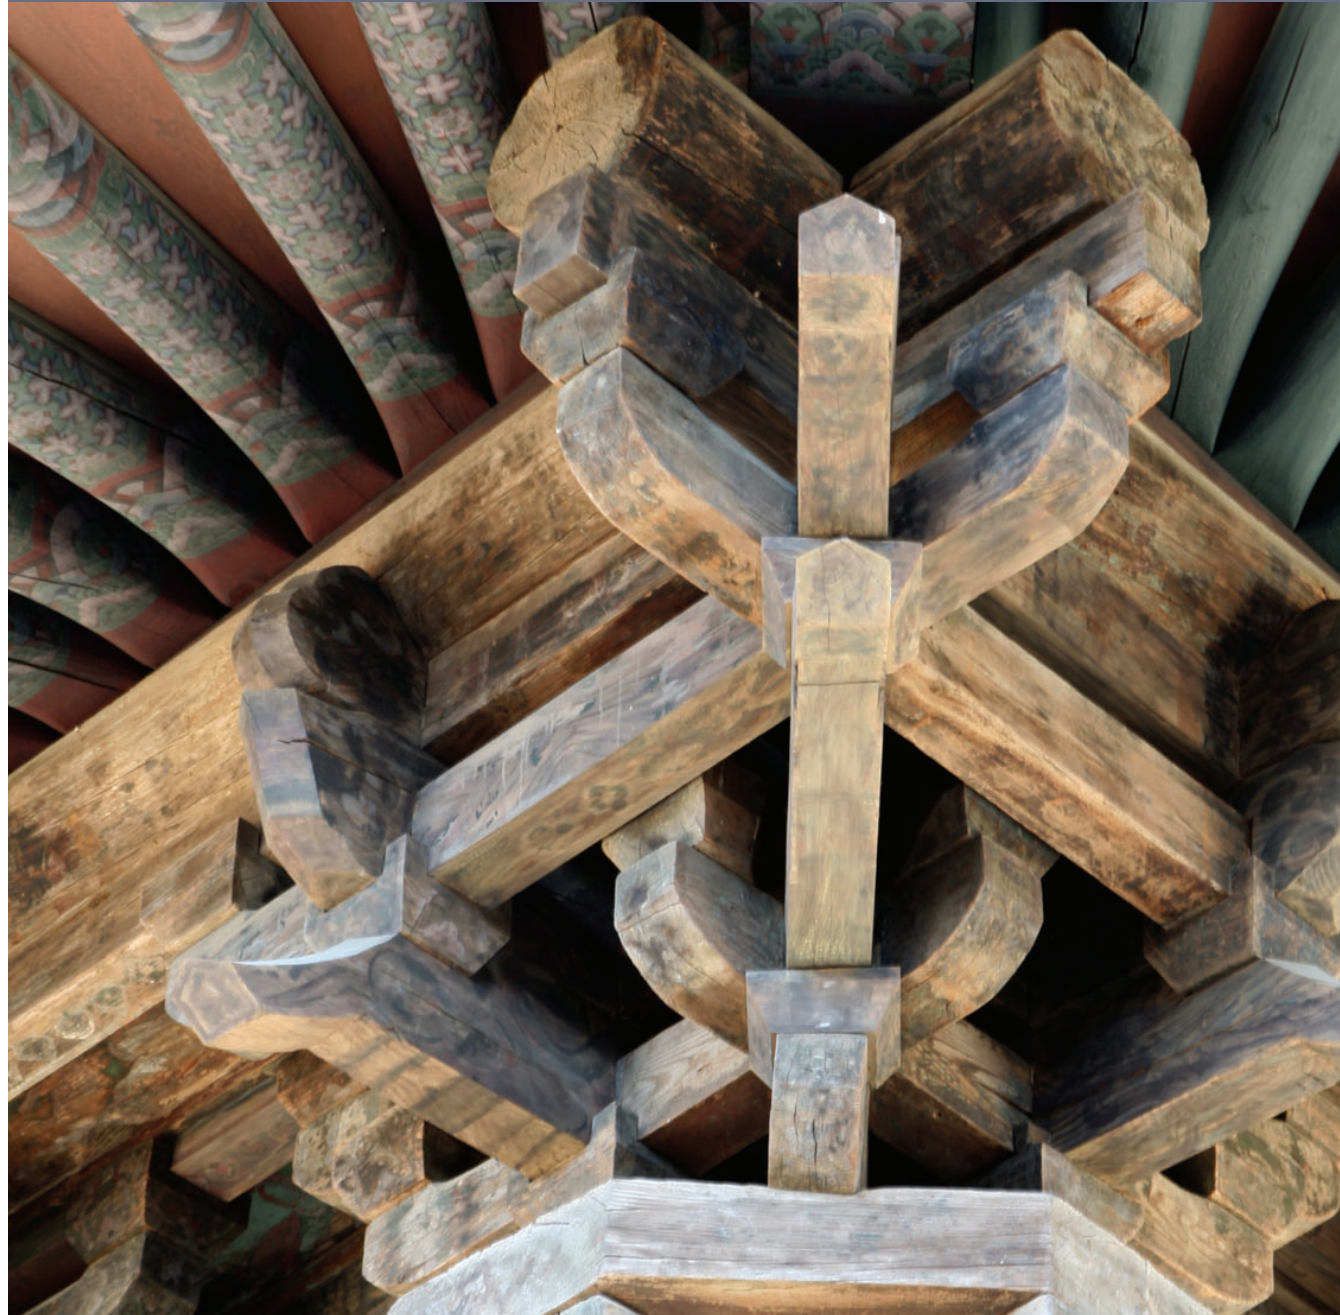
Detail of the multibracket system used in the construction of the Hall of Paradise (Geukrakjeon), in Bongjeong Temple, South Korea. Photo: Jong Hyun Lim.

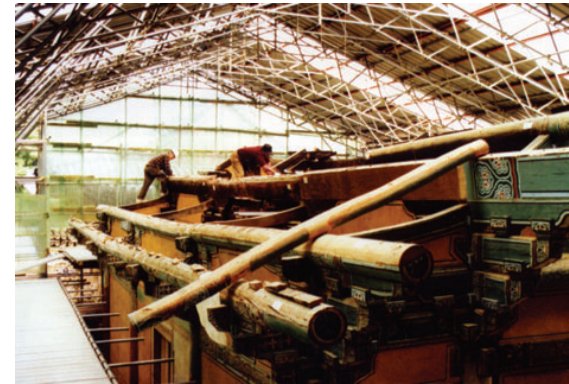
The Hall of Paradise, during restoration. Dismantlement of the temple allowed each building component to be documented individually. Photo: © Soon-Kwan Kim.

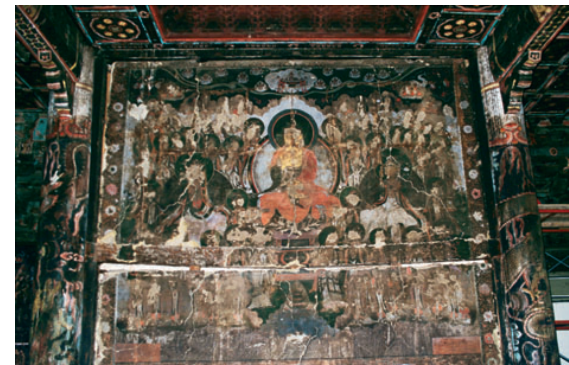
A Buddhist wall painting on the back side of the Main Sanctuary (Daeungjeon), during restoration. Photo: © Soon-Kwan Kim.

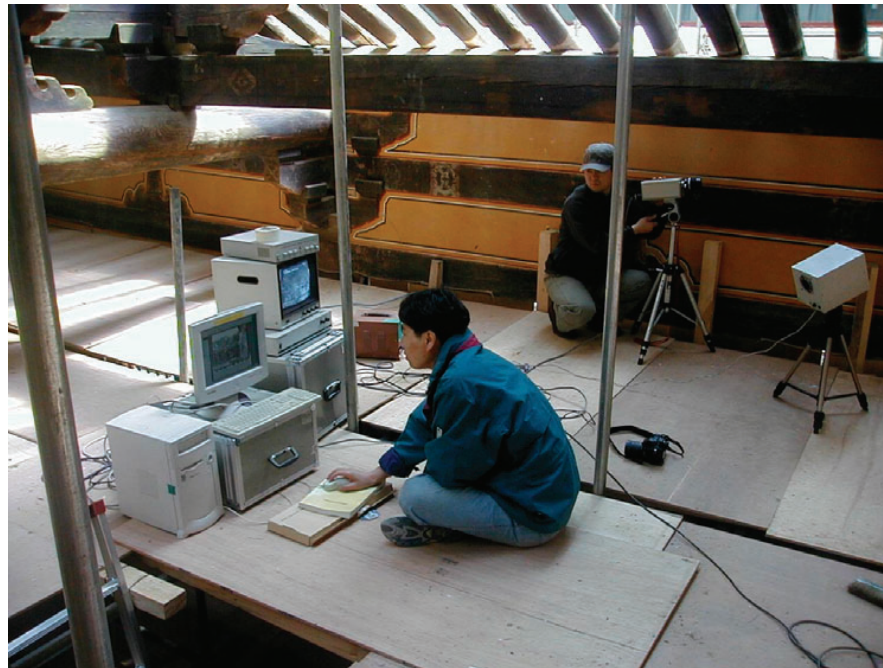
IRR acquisition of the images was conducted both on the individual components and in situ for the composite building. Photo: © Soon-Kwan Kim.
